DELAWARE WATER GAP

NATIONAL RECREATION AREA

HISTORICAL

ARCHITECTURAL SURVEY

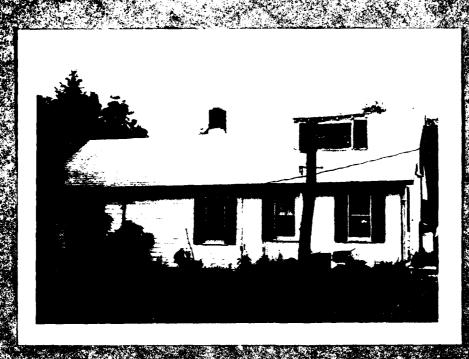
Architectural Significance: A building of cheap construction and lacking in style

Evaluation: Recommended for Category V

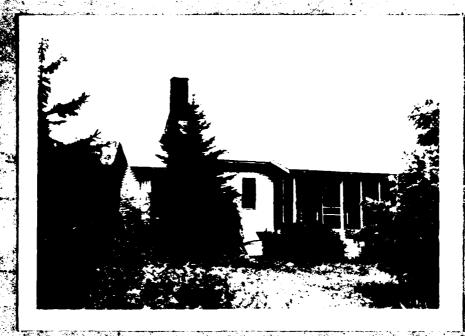
Architectural Significance: A house of no particular merit

Evaluation: Recommended for Category V

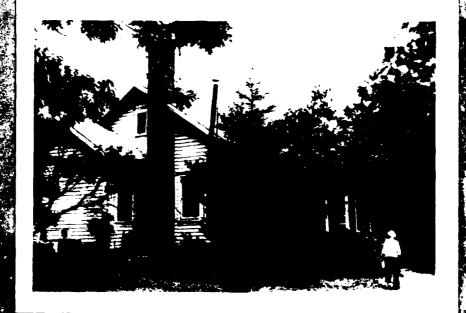
Tract 121 - NON-POOL AREA

Evaluation: This building should be in Category V. It is realized that it is presently in use as a Category II structure but it is aesthetically offensive and its construction crude; therefore, it is recommended that it be demolished as soon as possible

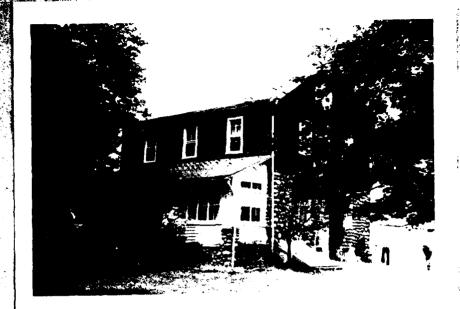
Architectural Significance: A poor quality building with no integrated style and gross detailing

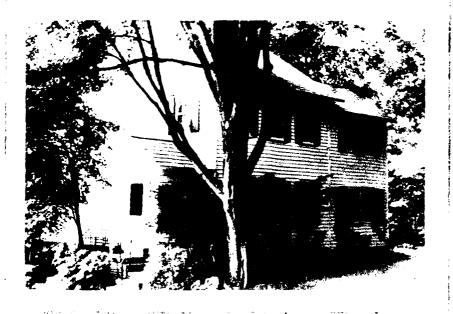
Architectural Significance: Structure has been radically altered, leaving little of original detailing. Too extensively remodelled to justify preservation

Evaluation: Recommended for Category V should present Category II be no longer needed

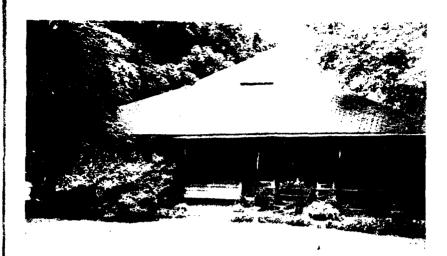
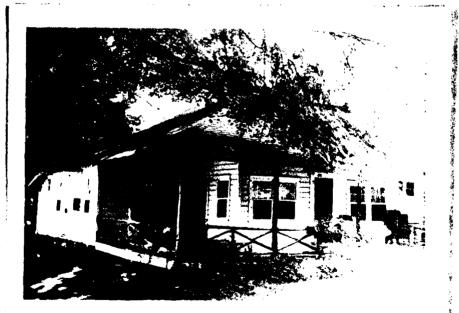
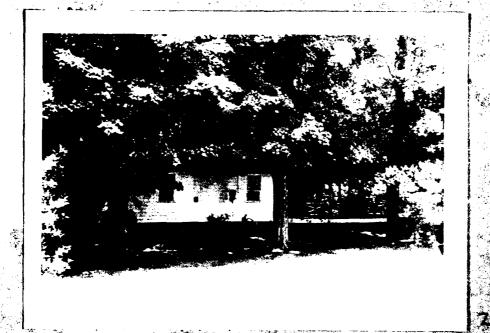
Tract 7310 - POOL AREA

1-story, frame Riverstone foundation Novelty wood siding; wood shingles in gable Roof, hipped (high, with end gables), asphalt shingles Dormers for lighting cathedral ceiling 2 Chimneys, riverstone and concrete block Windows, 20th Century 6/6 but with no parting bead Trim plain

Main house recommended for Category IV Evaluation:

Guest cottage recommended for Category V

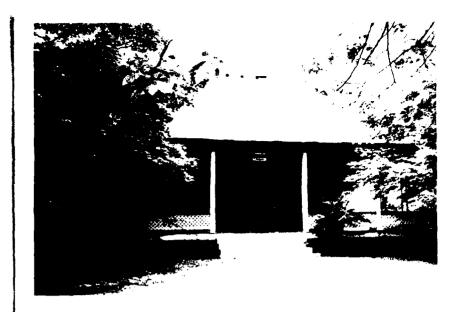
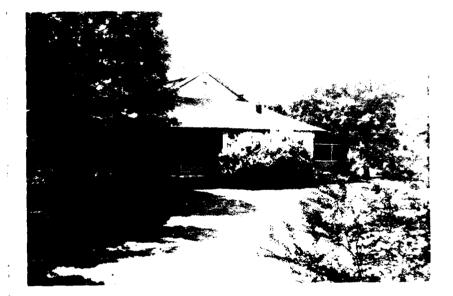
7310

1-1/2-story, frame
Rusticated concrete block foundation
Wood siding
Roof, asphalt shingles
Windows, 3/1 (top sash, 3 vertical panes)
 Trim, plain
Porch, heavy, round posts, tapered

Architectural Significance: A small house of no merit

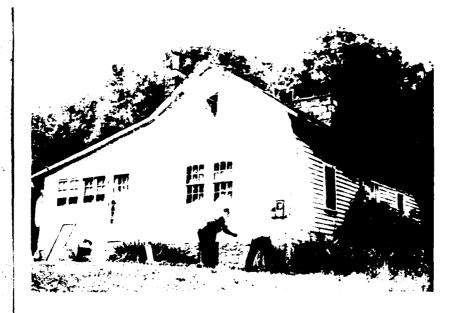
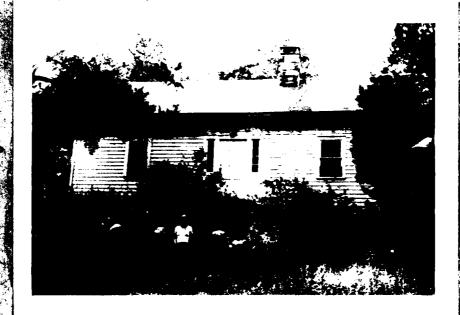
Tract 7357 - Sheet #2

Partitions and original plaster on exterior walls removed and replaced by wallboard

Door and window trim and baseboards, all replaced

Architectural Significance: The shape of the house, its one-room depth, its central chimmey and the exposed beam ceiling with finished timbers, all affirm an early date for this house. It is unfortunate that so much of its original detailing was replaced or altered during the middle of the 20th Century, but the unharmed cellar kitchen provides a compelling reason for considering this structure as quite significant

Evaluation: Recommended for Category VI for preservation of the kitchen

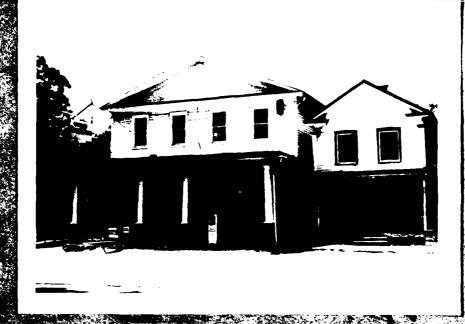
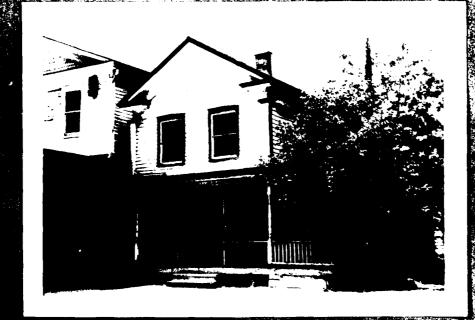
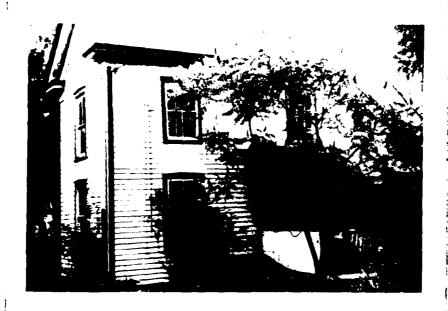
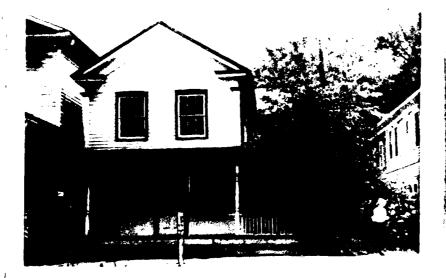
Tract 7423 - Building #1 - Sheet #2

Historical Significance: This Tinsmith's Shop is the only example found within the Project Area of an early 19th Century retail store

Architectural Significance: This small building is one of the few in the Project Area that bears the Classic Revival influence; it exhibits fine detailing and tasteful design and remains in good condition. Interior inspection would probably determine whether the building had been remodelled during the 1870's and whether or not the rear wing had also been added at that time; such information is, however, of minor consequence in evaluating the importance of the building since the changes made were of good quality in both design and workmanship

Evaluation: Recommended for consideration for Category I

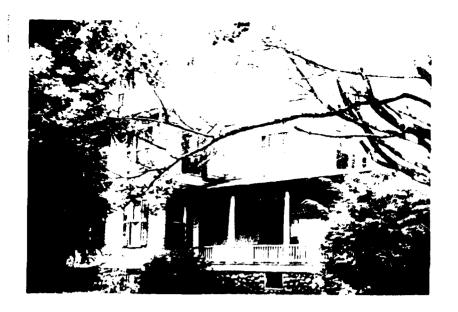
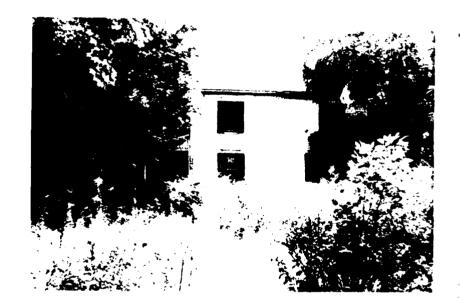
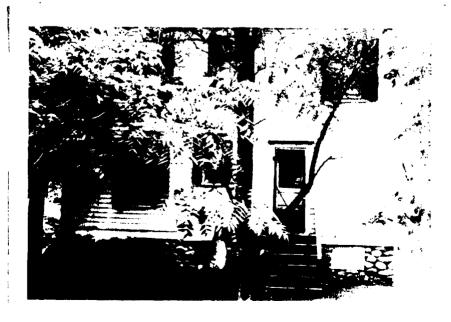
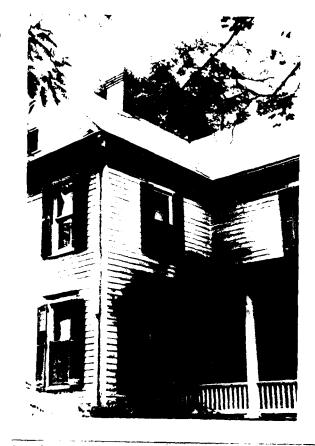
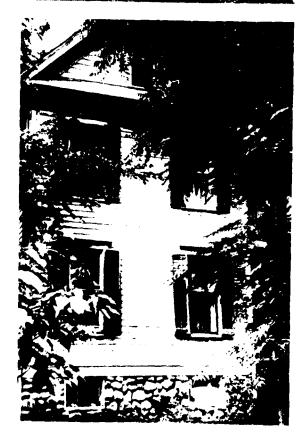
Tract 7446 - Sheet #2

Elegant stair, in beautiful condition

Architectural Significance: This house does not need restoration. It was well built and has been maintained with care so that, with minor exceptions, it is in good condition.

Evaluation: Recommended for Category I

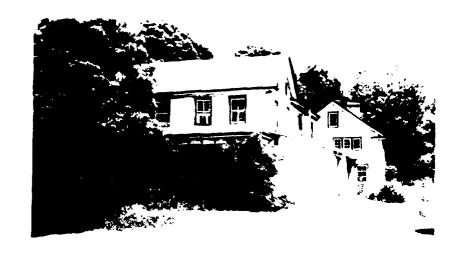
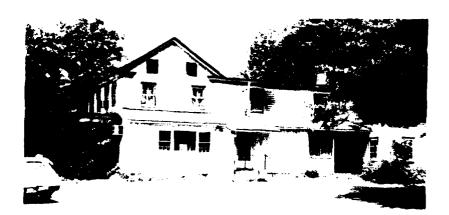
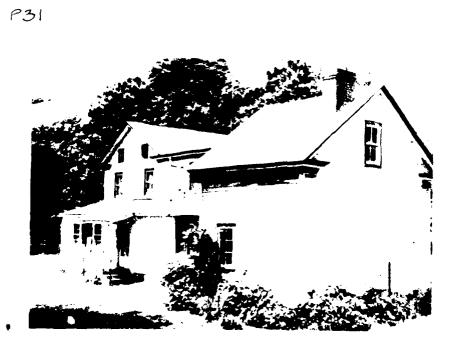
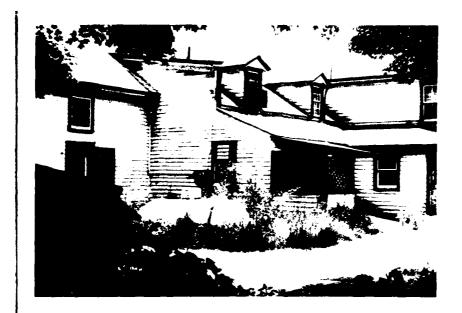
7447

Main Rear Addition:
1-1/2-story, frame
Riverstone foundation
Wood siding
Roof, slate
Eave returns with mouldings, traditional
Brick chimney
Windows, 6-light casements and 2/2
Trim plain, squared drip

Architectural Significance: In only fair condition and showing only some of the original detailing, this structure has evidently suffered considerable damage through alteration to accommodate present tavern usage. Many other examples of the same period are still standing in the Park Area and remain in better condition

Evaluation: Recommended for Category V

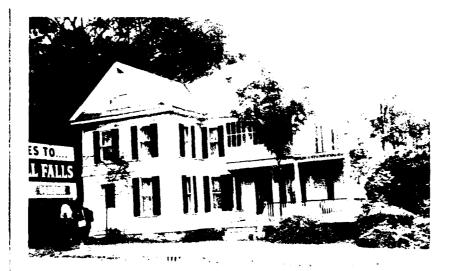
P15

Architectural Significance: This house is a tasteful example of late 19th Century construction with the square "L" form, with mild concessions to Queen Anne and Eastlake freedom in plan and ornament, as evidenced by the porch which wraps around the corner; the balcony which was clearly an open porch; by the variation in siding materials, particularly the patterned shingle band, the gable sumburst and windows, the two-story bay and the entrance door trim. The house appears to have suffered little alteration on the exterior and deserves interior inspection.

Evaluation: Recommended for Category IV

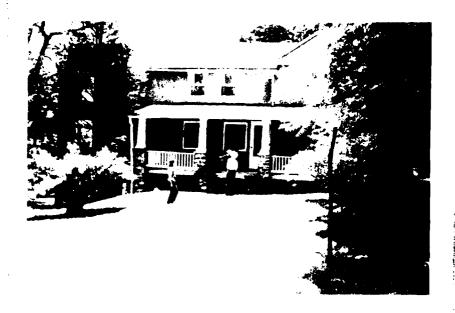
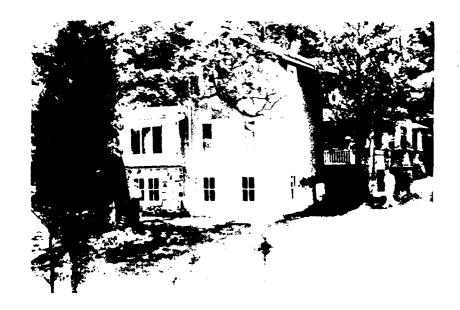
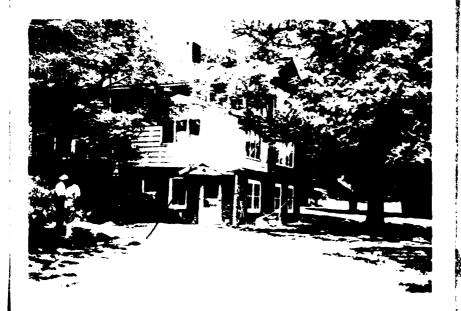
Historical Significance: The original, earlier farmhouse on the hill behind this house was destroyed some time ago. It had been built by the original settler, Cornelius Angle. This 1850's house was built by the son of Cornelius

Several of the boards in the vertical siding of the 1850's barn show holes bored in them which are about the size of peg holes and which are reputed to have resulted from the rafting of the original logs down river

Note: Category VIII protection needed. Recent road work has changed the drainage from the road, with the result that the bank is being eroded and damage is being caused to the excellent stonework. This has not progressed far and corrections carried out shortly would prevent irreparable damage

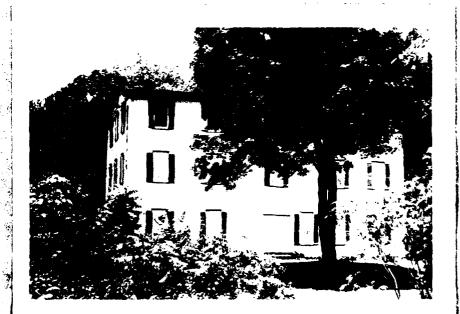
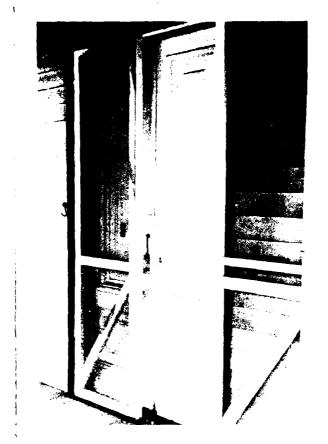
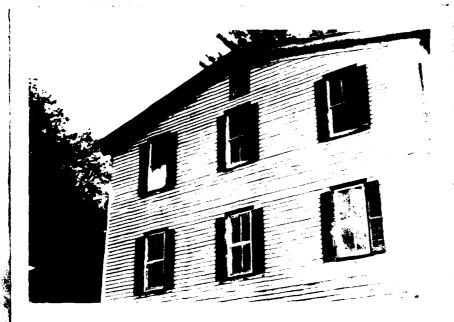
Historical Significance: This 31-room hotel represents the fame of this region as a resort area for New York and Philadelphia

Architectural Significance: A simple building with no particular distinction; however, its proportions are pleasing, despite its scale. Its original interior and exterior details appear to remain totally intact and it retains the dignity of its period. Unfortunately, since it does not conform to today's standards of safety, it has lost its utility as housing

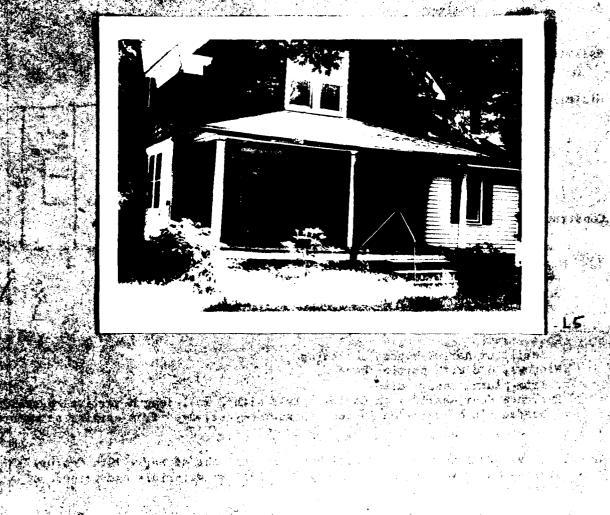
Tract 10549 - POOL AREA

Architectural Significance: A small house reminiscent of early 19th Century styling but revealing mostly early 20th Century materials and methods of construction

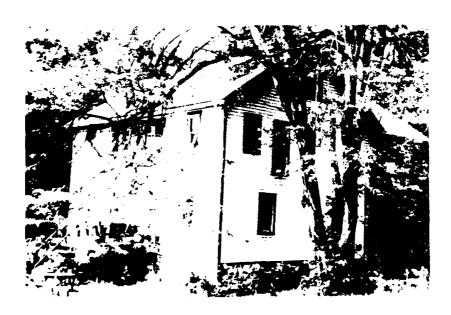
T-325, Delaware Township Pike County, Pennsylvania

Architectural Significance: This very small vacation cottage was built in the traditional country style but with no particular merit; it appears to have been abandoned in the midst of a remodelling job and is in poor condition

Evaluation: Recommended for Category V

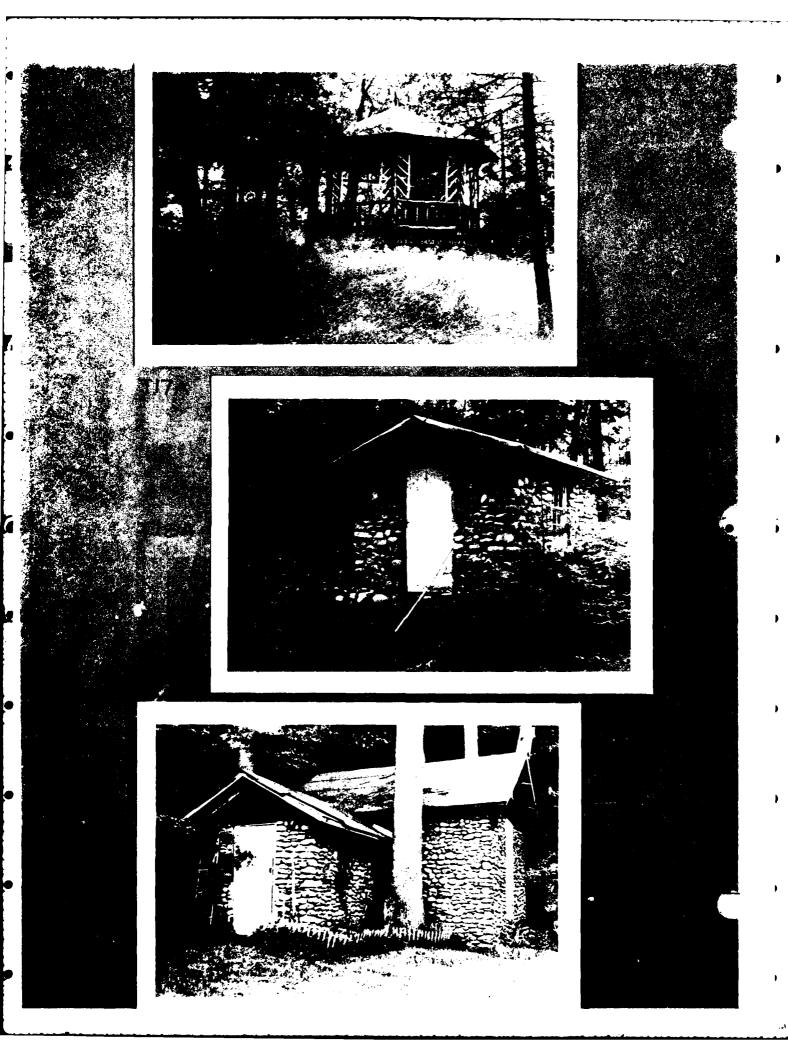
Tract 11907 - Sheet #2

- 1. Two small, riverstone buildings in good condition
- Garage, beside road, downhill from house, at foot of walkway
 2-story, frame
- 3. Large, octagonal gazebo of natural wood on hill above house
- 4. Pump-house below main structure

Evaluation: Recommended for Category I
